# NomadStamp

## Vehicle record — YF18 KXN

| Make and model | Fiat Ducato 2.3 MultiJet — Auto-Trail Tracker EKS |

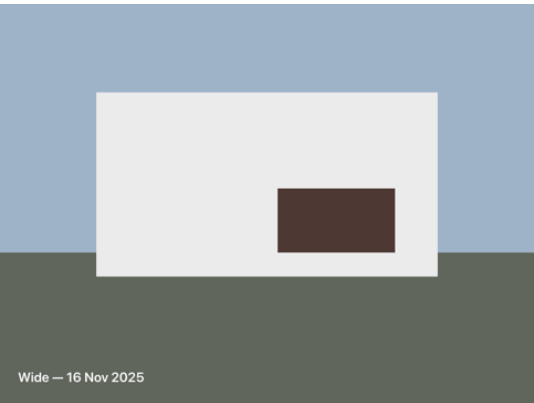
Damage, 16 Nov 2025 — Wide

| Date | What happened | Repaired | Cost |
|---|---|---|---|
| 16 Nov 2025 | Stone off a lorry chipped the windscreen, low down on the passenger side. Not in the swept area.<br>A66 near Bowes · Watching it. Insurer says it's a replacement not a repair if it spreads. | No | |

| Date | Work done | Odometer | Cost |
|---|---|---|---|
| 30 Jun 2026 | Windscreen chip monitored, no repair carried out. Inspection only.<br>Autoglass · AG-2606-4471 | 45,100 | £0.00 |

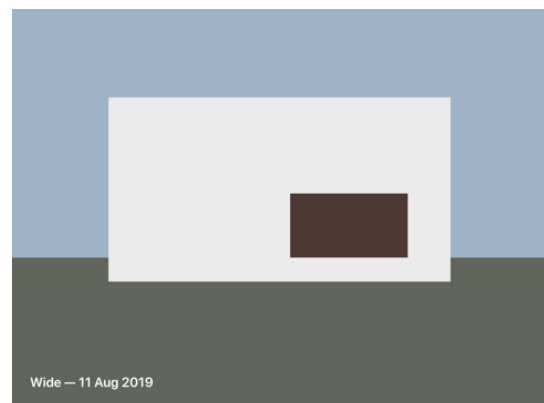
Damage, 11 Aug 2019 — Wide

| Date | What happened | Repaired | Cost |
|---|---|---|---|
| 11 Aug 2019 | Reversed into a low stone bollard I couldn't see over the rear. Cracked the offside rear light cluster and scuffed the panel below it.<br>Aire at Honfleur, Normandy · Repaired October 2019 at Marquis. New cluster, panel filled and resprayed. | Yes | £420.00 |

| 14 Oct 2019 | Offside rear light cluster replaced, panel filled and resprayed after the Honfleur bollard.<br>Marquis Preston · MQ-126718 | 7,910 | £420.00 |
